Draft Final Report • National Institute of Standards and Technology (NIST)

of the May 22, 2011,
Tornado in
Joplin, Missouri

NIST NCSTAR 3 (Draft)

November 2013

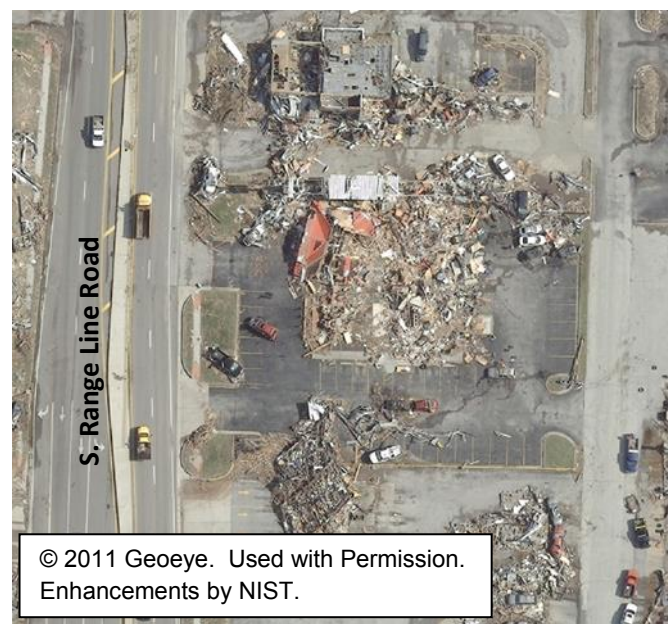
Figure 4–31. Aerial photo showing damage to the Joplin Pizza Hut.

Through observation of aerial photos (Fig. 4–31), it was found that the Joplin Pizza Hut was completely demolished as a result of the tornado. The building’s entire roof system disintegrated and all wood-frame supporting walls collapsed. Also, building materials from collapsed components fell into the interior of the building.

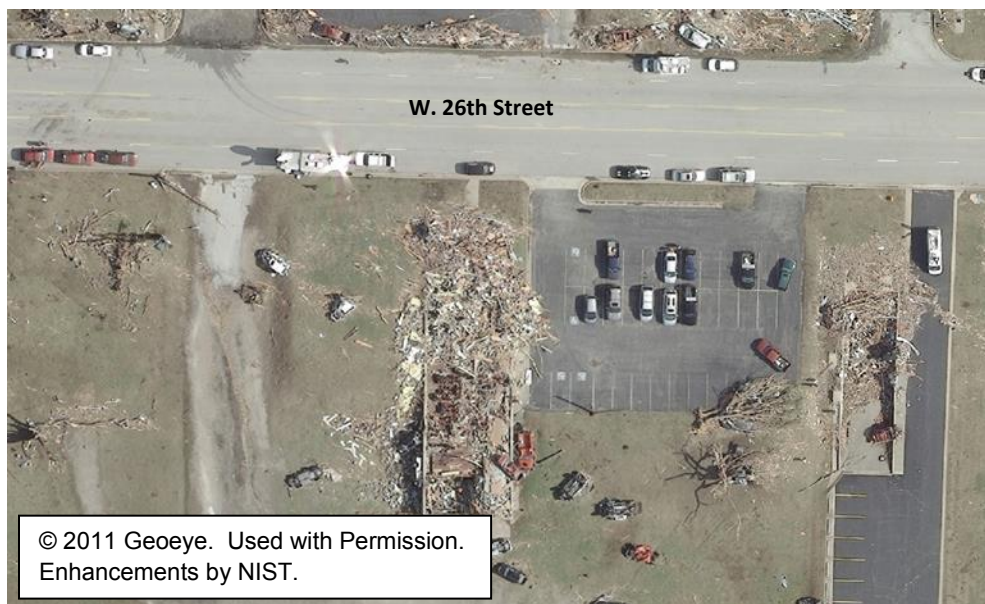
Figure 4–32. Aerial photo showing damage to the Stained Glass Theater.

Finally, the Stained Glass Theater sustained complete demolition, with disconnection (and disintegration) of the wood roof system and partial collapse of the exterior CMU walls. Most building materials from damaged building components ended up in all areas of the building interior. Damage to the building can be seen in Fig. 4–32.

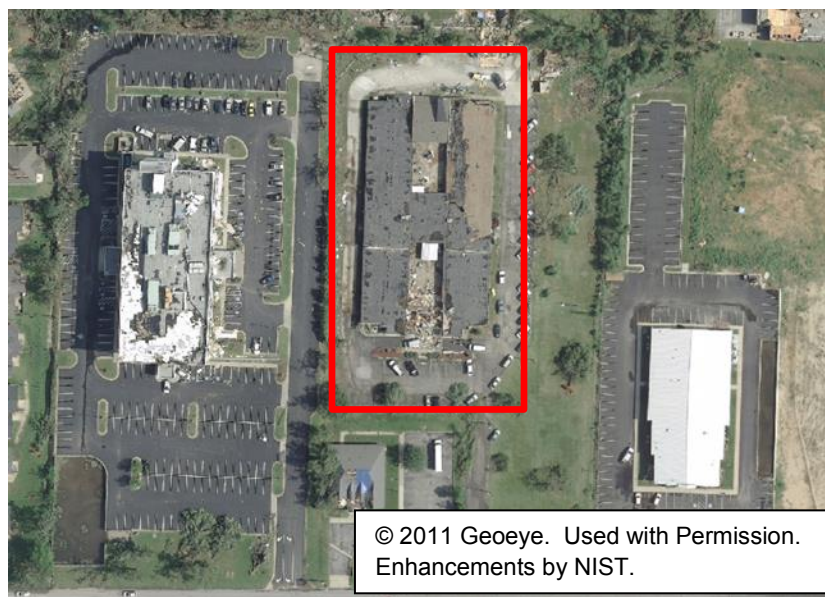
The Meadows Healthcare facility was exposed to lower wind speeds than the other buildings in Table 4–6. Even so, the damage to this structure was rated as “heavy/totaled,” and is shown in Fig. 4–33. Two fatalities occurred in this building. One of these two victims had reportedly been ill with cancer prior to the storm.¹⁵¹ It is not known if the other victim was also ill when the storm hit; however, both individuals

Figure 4–33. Aerial photo showing damage to the Meadows Healthcare facility (outlined in red).

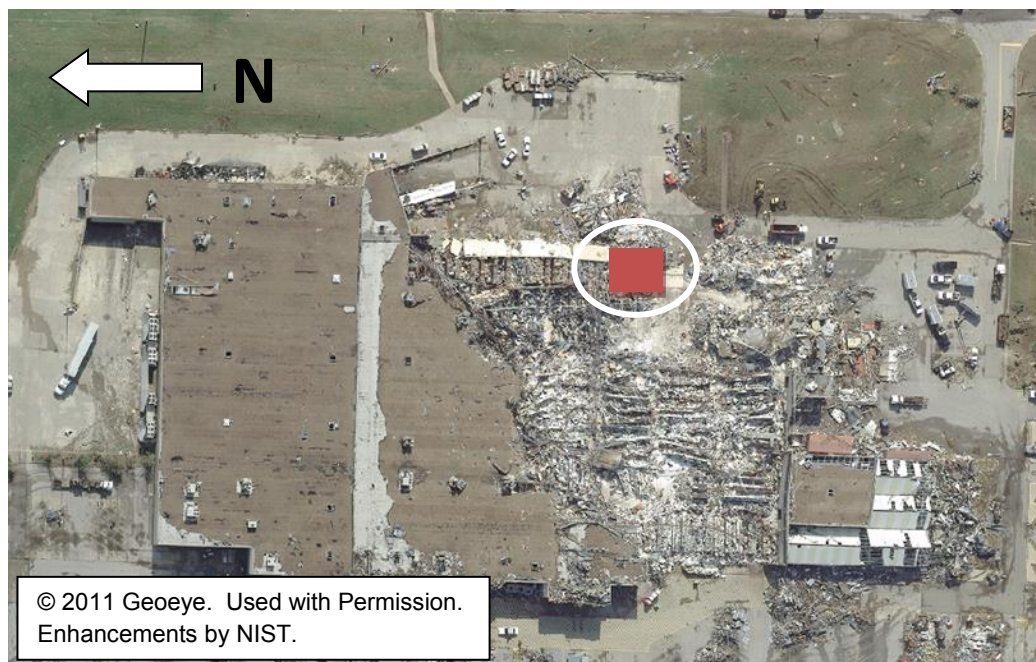
Figure 4–34. Aerial photo showing damage to Walmart Store #59, including the red box (circled in white) to indicate the store’s refuge area.

Within the collapsed area, where patrons are known to have congregated during the tornado, the building lost all of its roof decks and joists. Although the majority of the joist girders remained in place, and all columns remained in place, large sections of the leeward concrete masonry walls collapsed inward. The exterior wall of the refuge area was one of the walls that collapsed inward, and it fell into the area where 50 to 60 people had congregated. According to an interviewee, the collapsed wall closest to the refuge area rested on a set of cabinets nearby, creating a D-shaped pocket of safety.

The wind and debris hazard produced by this tornado, as estimated by the wind field model presented in Chapter 2, exceeded the conditions that this store was designed to withstand. In consequence, the Walmart building, specifically the southern half of the building in which many people were located, suffered complete collapse, which can be categorized as “demolished” (similar to most of the buildings discussed in the preceding section). Additional information on the possible failure sequence that led to the building’s collapse can be found in Chapter 3. The store did not have an underground location (or basement) or an indoor storm shelter where patrons could shelter from the storm. The structural collapse of a portion of the Walmart building on May 22, 2011, is thought to have caused three fatalities and an unknown number of injuries among the approximately 200 occupants located inside the building during the storm. However, no official information was found by NIST on the exact location inside the store of the three fatalities.

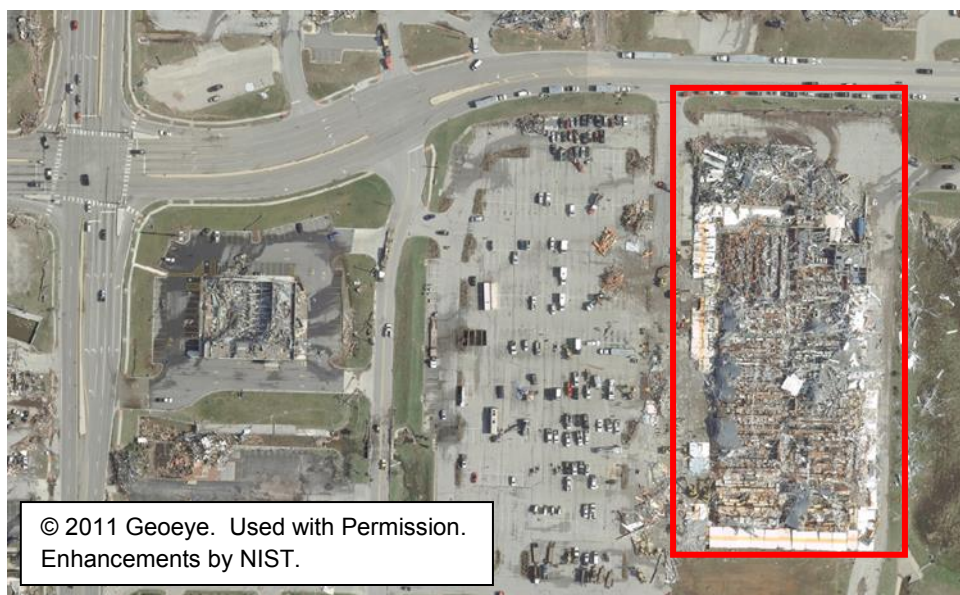
The Home Depot's perimeter tilt-up walls and roof system completely collapsed during the tornado. In total, 63 of the 73 wall panels collapsed either inward or outward, leaving 10 standing after the storm. Due to the wind and debris damage it sustained, this building was categorized as "demolished" in the GIS database. An aerial photo of the damage to the Home Depot is shown in Fig. 4-35.

Figure 4-35.
Aerial photo
showing
damage to the
Home Depot
(outlined in red).

The wind and debris hazard produced by this tornado, as estimated by the wind field model presented in Chapter 2, exceeded the conditions that this building was designed to withstand. In consequence, the Home Depot suffered a complete collapse. Additional information on the possible failure sequence that led to the building's collapse can be found in Chapter 3. Similar to Walmart, the Home Depot did not

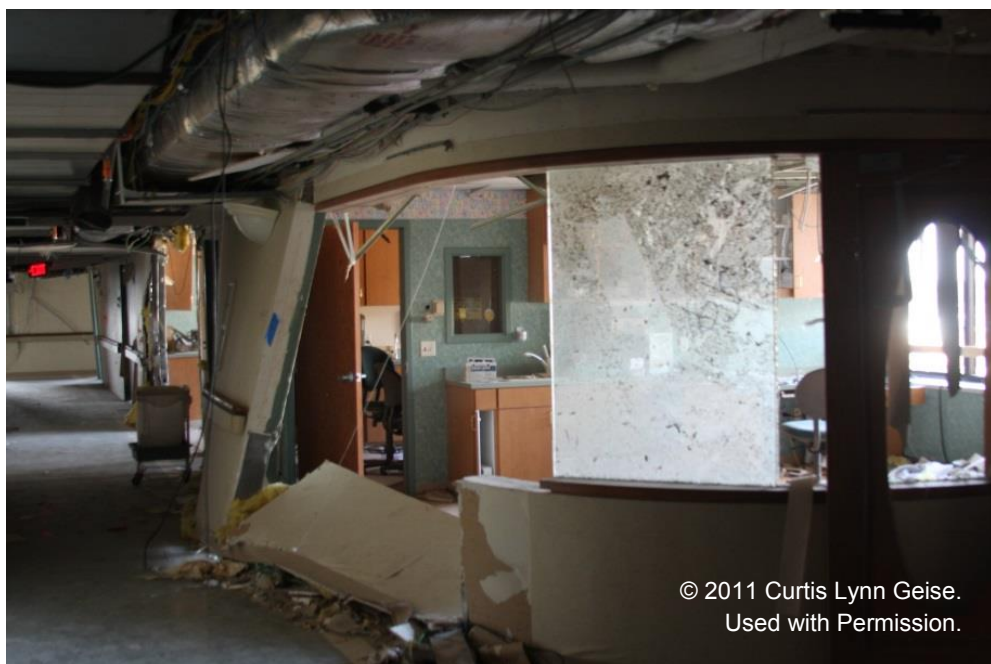
During the tornado, the towers were exposed to an estimated maximum wind speed of 170 mph \pm 20 mph (the EF-4 wind speed range). As mentioned in Chapter 3, the towers primarily sustained damage to their building envelopes and interiors, but did so without structural collapse. The damage to these buildings included the breakage of almost all vertical glass; damage to the roof systems, including the loss of aggregate roof ballast, which became wind-borne debris that further damaged the facility and the surrounding areas (see Chapter 3); damage to the interiors, including the breakage or collapse of interior partitions, suspended ceiling systems, furniture, fixtures, and equipment; damage to sections of gypsum-metal stud walls surrounding the elevator shaft and to the elevator equipment itself; and water and debris infiltration onto the floors. A view of the interior damage can be seen in Fig. 4-36.

Figure 4-36.
Damage to the
interior of
SJRM.

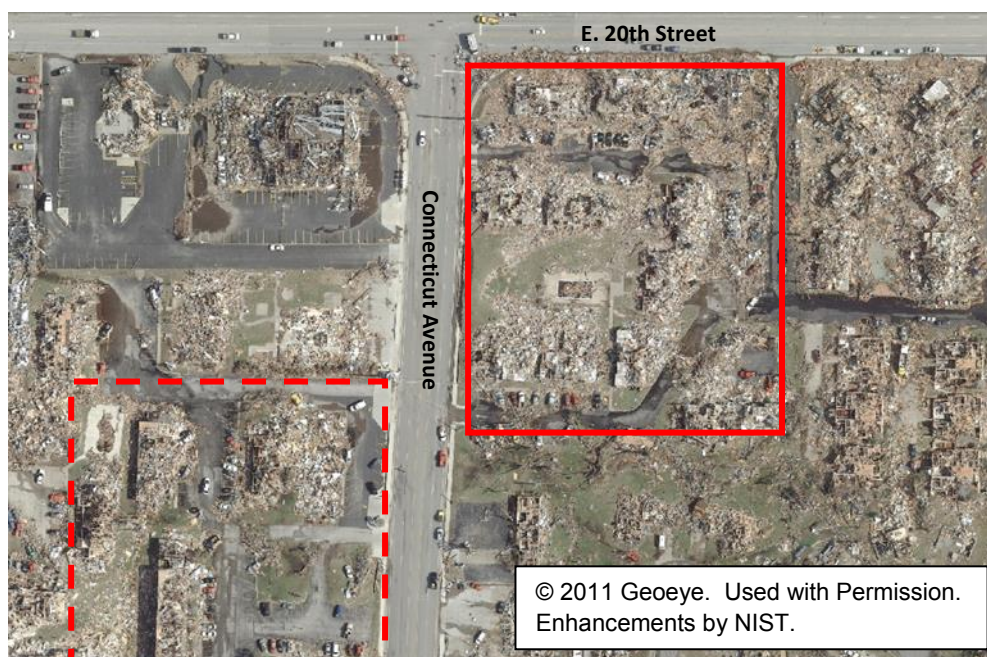
Figure 4–37. Aerial photo showing damage to two apartment complexes in Joplin at 2001 Connecticut Avenue (outlined by solid red line) and 2034 Connecticut Avenue (within dotted line).

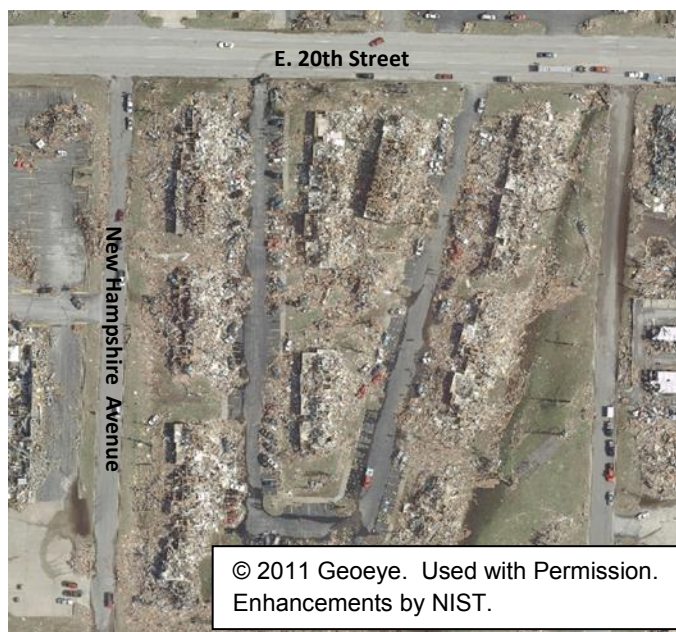
Figure 4–38. Aerial photo showing damage to the Hampshire Terrace apartments.

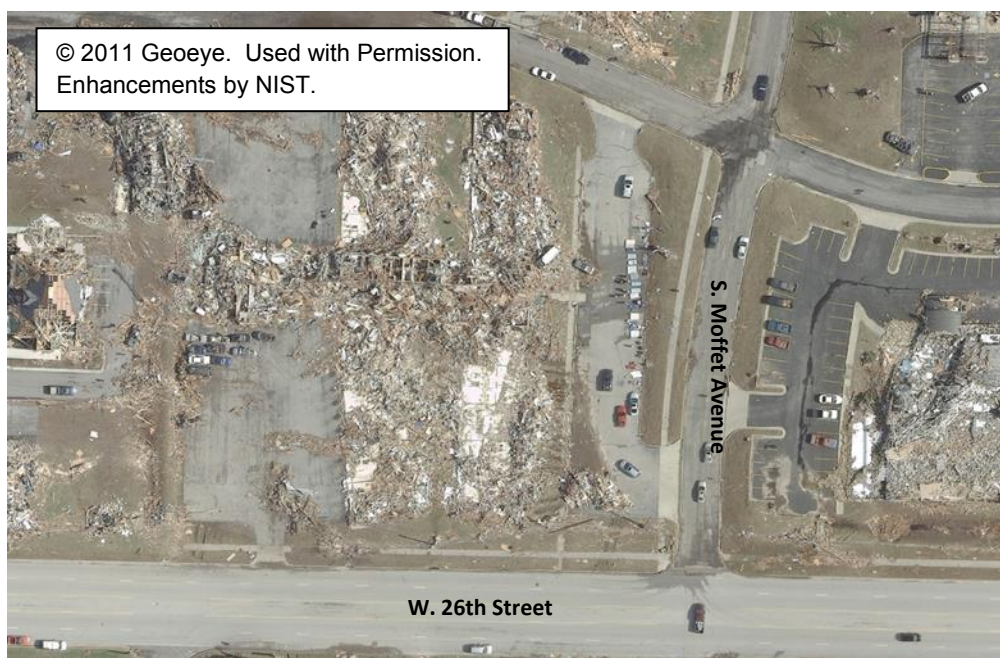
Nineteen individuals died in the Greenbriar Nursing Home. The structure was exposed to an estimated maximum wind speed of $170 \text{ mph} \pm 20 \text{ mph}$. The building was an unreinforced masonry structure. Damage to the structure, rated as “demolished”, is shown in Fig. 4–39. It is unclear where the 19 fatalities were located within the Greenbriar; however, there were also five individuals (from the CDC sample) located at the Greenbriar who sustained severe injuries and were located in the hallway, a bedroom, and a doorway inside the structure.

Figure 4–39. Aerial photo showing damage to the Greenbriar Nursing Home.

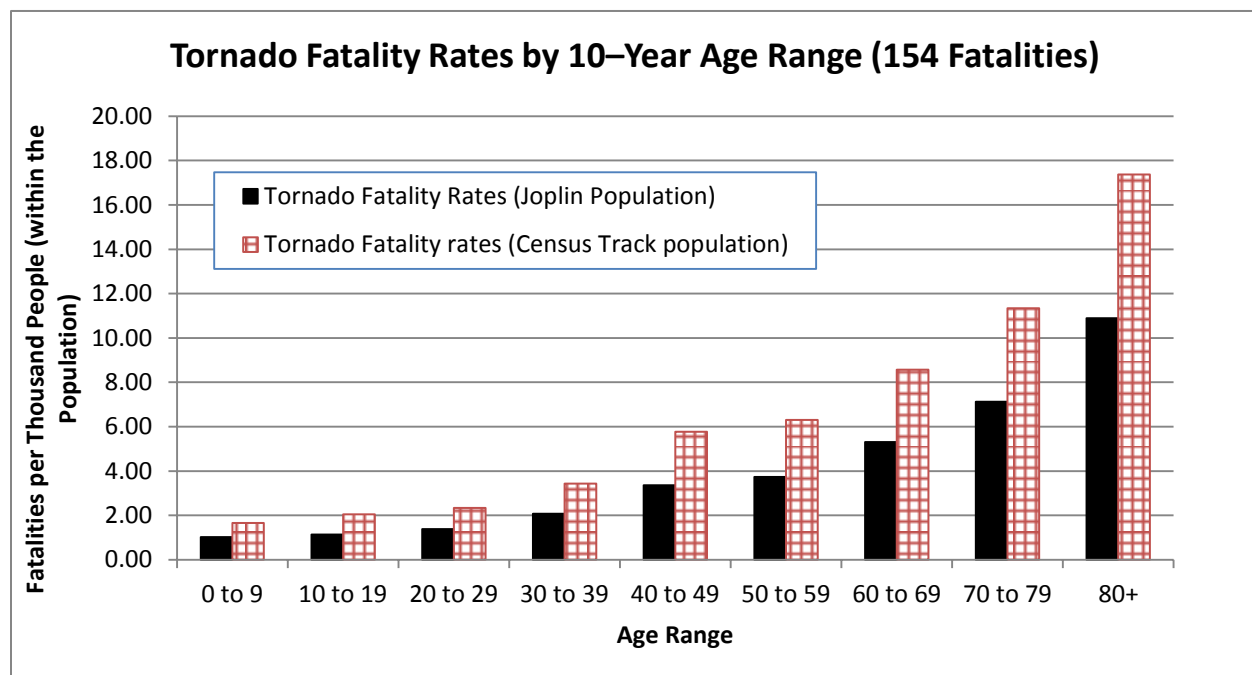
Some percentage of the decision-makers in this analysis who were unaware of the storm were older individuals (60 years old or above). It was shown earlier that a disproportionate number of older adults (aged 60 or above) died from this tornado (see Figures 4–18 and 4–19). It is plausible to suppose that some of these older decedents could have been hearing impaired, sleeping, and/or disconnected from tornado-related emergency communications when the event occurred, and/or without a social network, and as a result, died from this storm. When focused only on those individuals who died of impact-related causes (total 154), the data still showed that a disproportionately large number of older individuals (above the age of 60) died as a result of this storm (see Fig. 4–42).

Figure 4–42. Tornado fatality rates per thousand people within two populations: Population 1 – the entire population of Joplin and Population 2 – the population of the areas within Joplin most affected by the tornado (154 impact-related deaths)

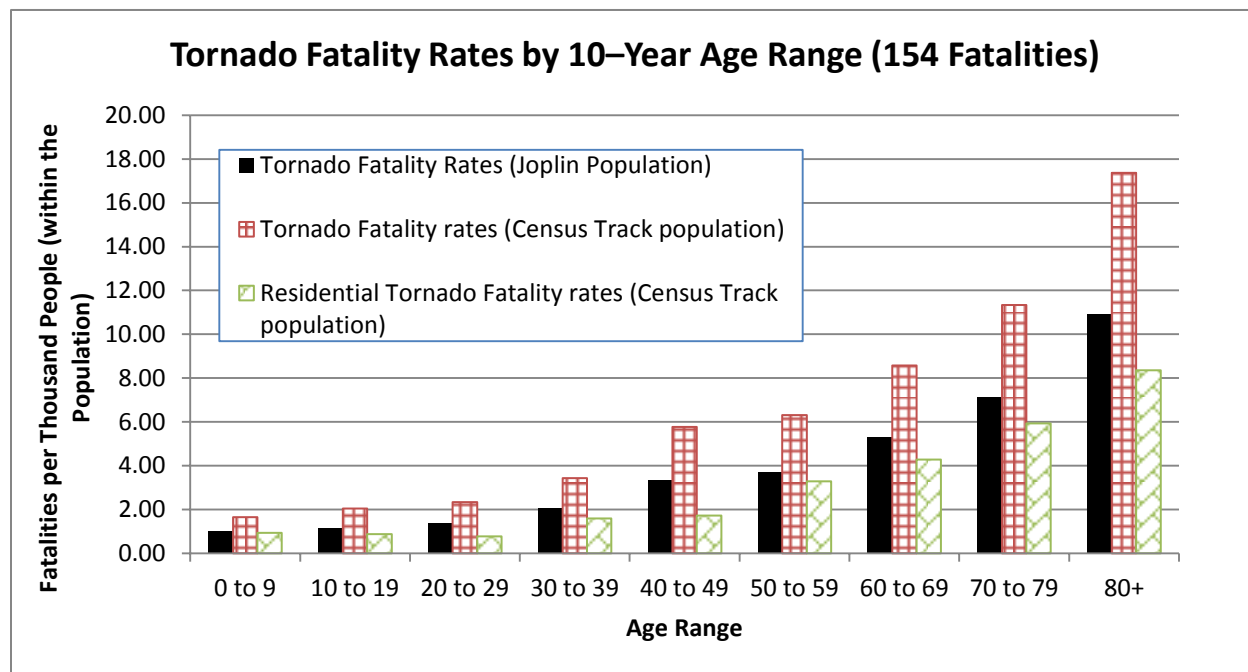
It is difficult to determine why older individuals were disproportionately represented among the deaths from the May 22, 2011, Joplin tornado. Even after removing those deaths that occurred in SJRMC and the two nursing homes, which were locations where one would expect older people to be overrepresented in comparison to their presence in the population, individuals 60 years old or older were still overrepresented among the remaining May 22, 2011, Joplin tornado fatalities (see Fig. 4–43 that includes the fatalities rates for those located and who died in single-family homes and apartments).

Figure 4–43. Tornado fatality rates (154 impact-related fatalities) and Residential tornado fatality rates (single-family homes and apartments, only)

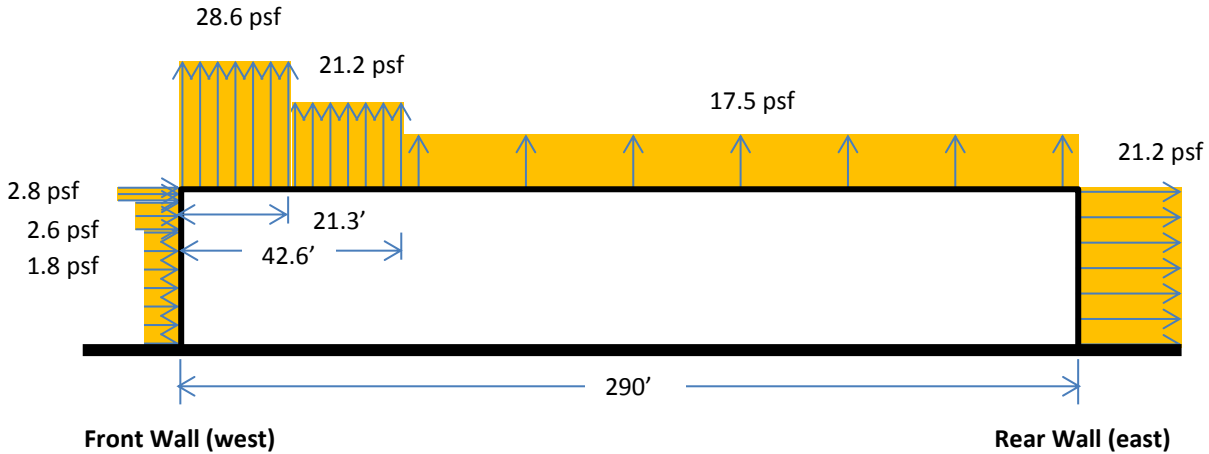
Wind pressure distribution corresponding to the net internal pressure case ($+GC_{pi}$), shown below in Fig. H-1, represents the worst load case for wind uplift, with estimated maximum design (code-level) net uplift pressure of 28.6 lb/ft² (psf) on the roof.

Figure H-1. Wind pressure distribution for the Walmart building.

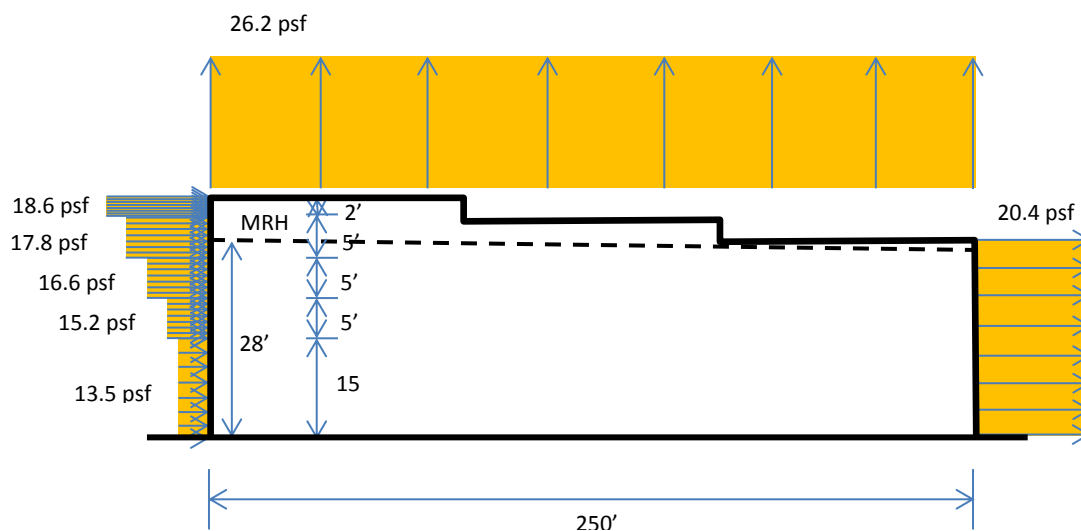
**Figure I-1. Wind pressure distribution for MWFRS of the Home Depot building.**

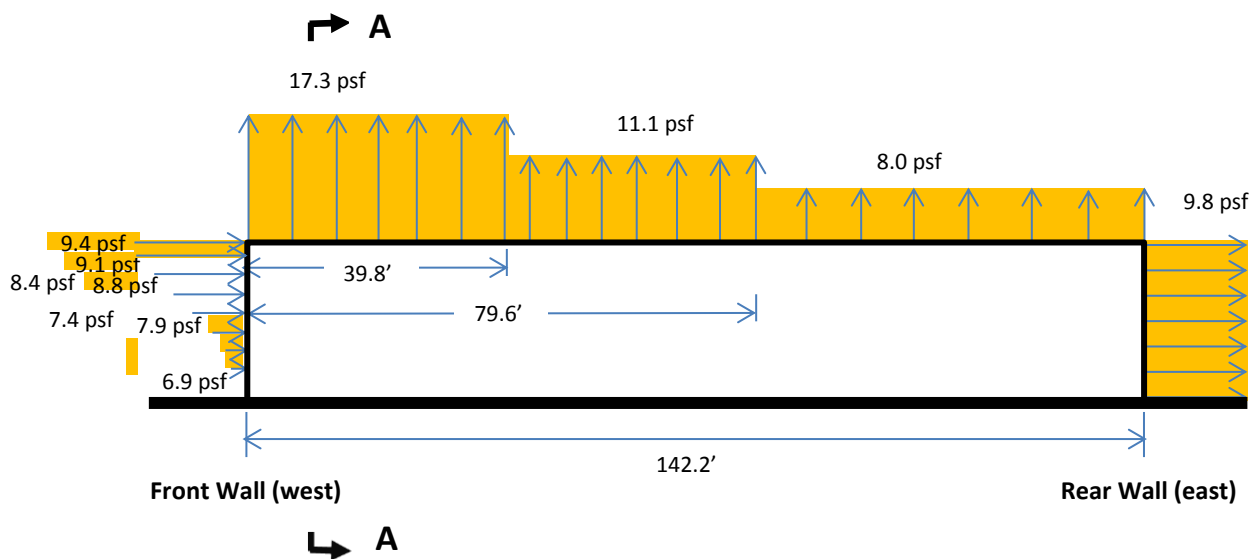
Figure J-1. Wind pressure distribution along length of the Joplin East Middle School Gymnasium.

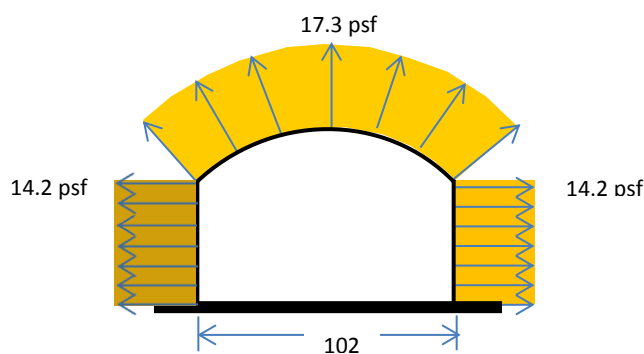
Section A-A

Figure J- 2. Wind pressure distribution on the cross section of the Joplin East Middle School Gymnasium.
